National Register of Historic Places
Inventory—Nomination Form

historic Indian Range

Continuation sheet Indian Range Anne Arundel County, MD Item number 7 Page 1

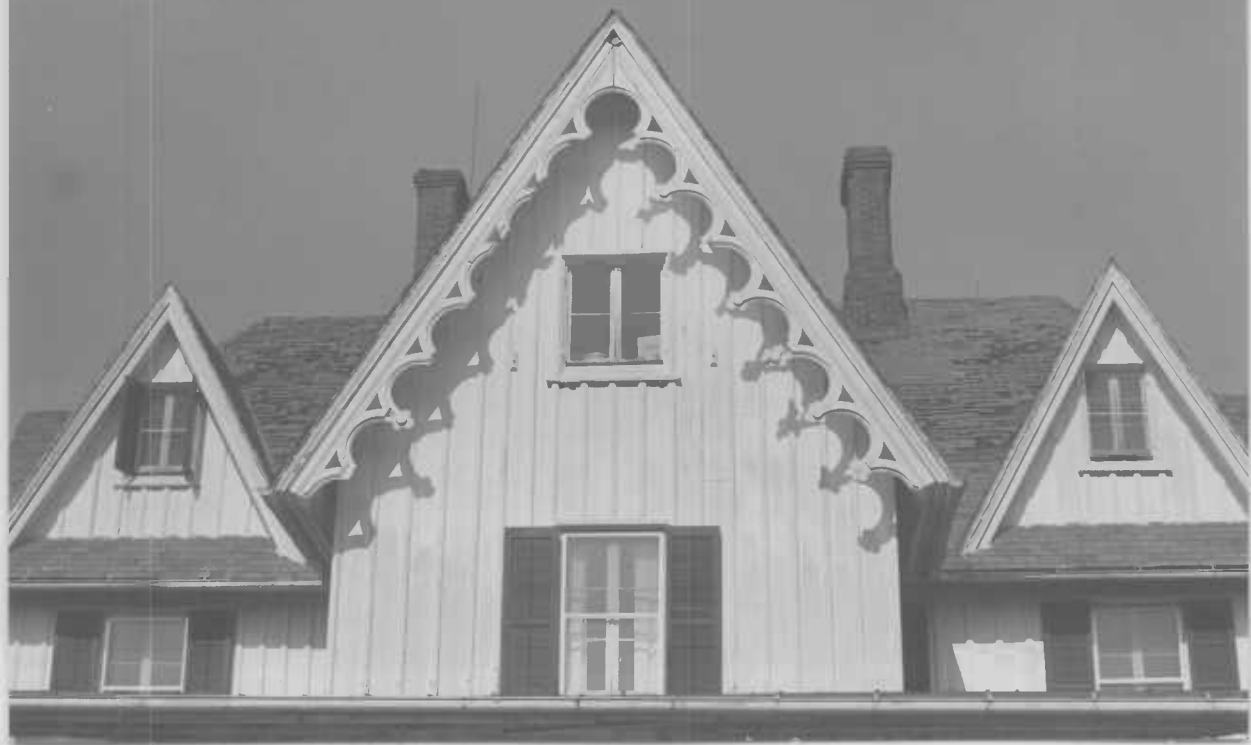
AA-29-N-a (map 22)
"Indian Range"
Detail front gable
& dormers
South Elevation

There are two gabled dormers with smaller windows on either side of the central projection and directly above the first and second floor bays. In the gable of the central projection is a pair of two pane in-swinging casement windows with shutters. The dormer windows do not have shutters.

Along the gable of the central projection is a plain fascia board. There is no gingerbread gable trim in place; however it is known that some existed on the gable of the central projection. Some of this trim is stored on the premises.

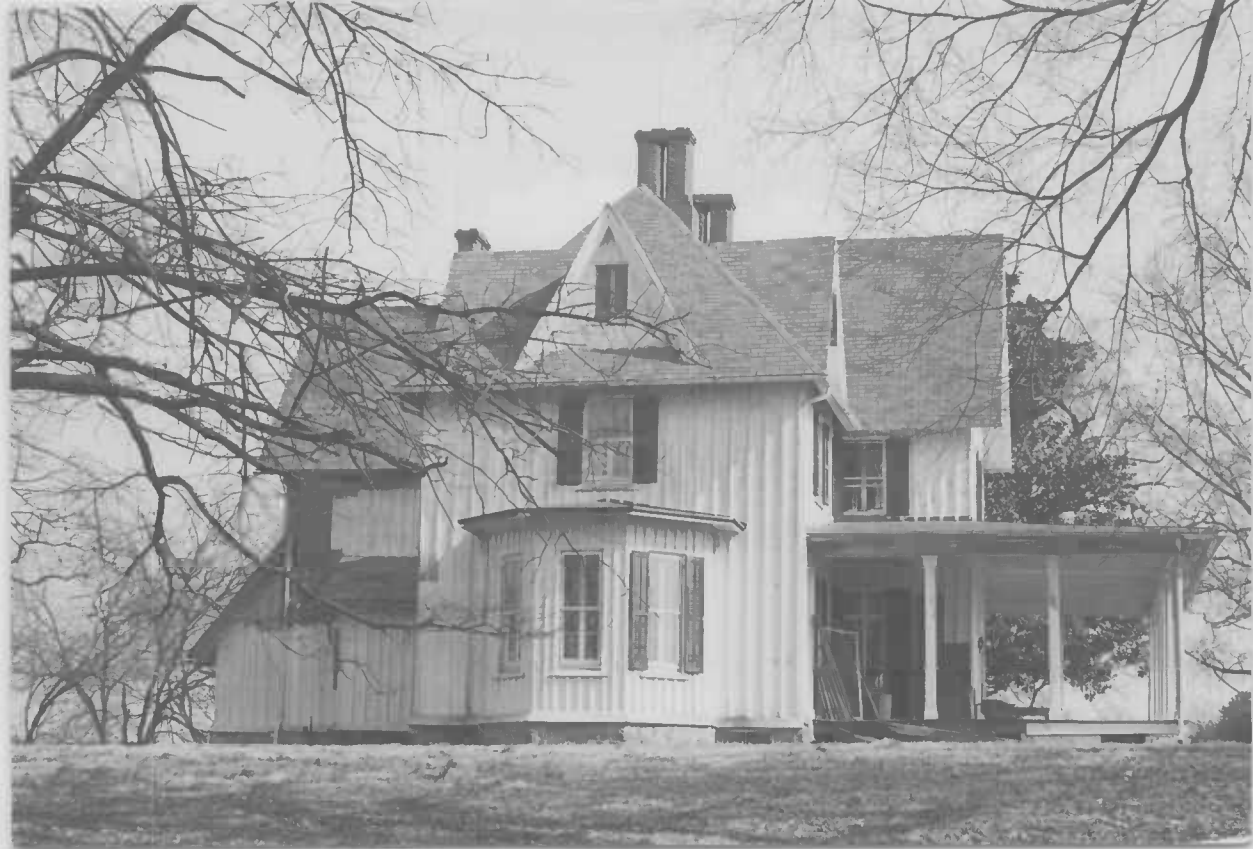
aa-29-N-a (map 22)
"Indian Range"
Main house
West Elevation

On the west facade of the main section is a semi-octagonal, one story, bay. There are three pair of four pane in-swinging casement windows. The bay has the same type of metal roof as the porch. On the second floor, centered above the bay, is a window and directly above this is a gabled dormer with a window. On each side of the bay is a small basement window.

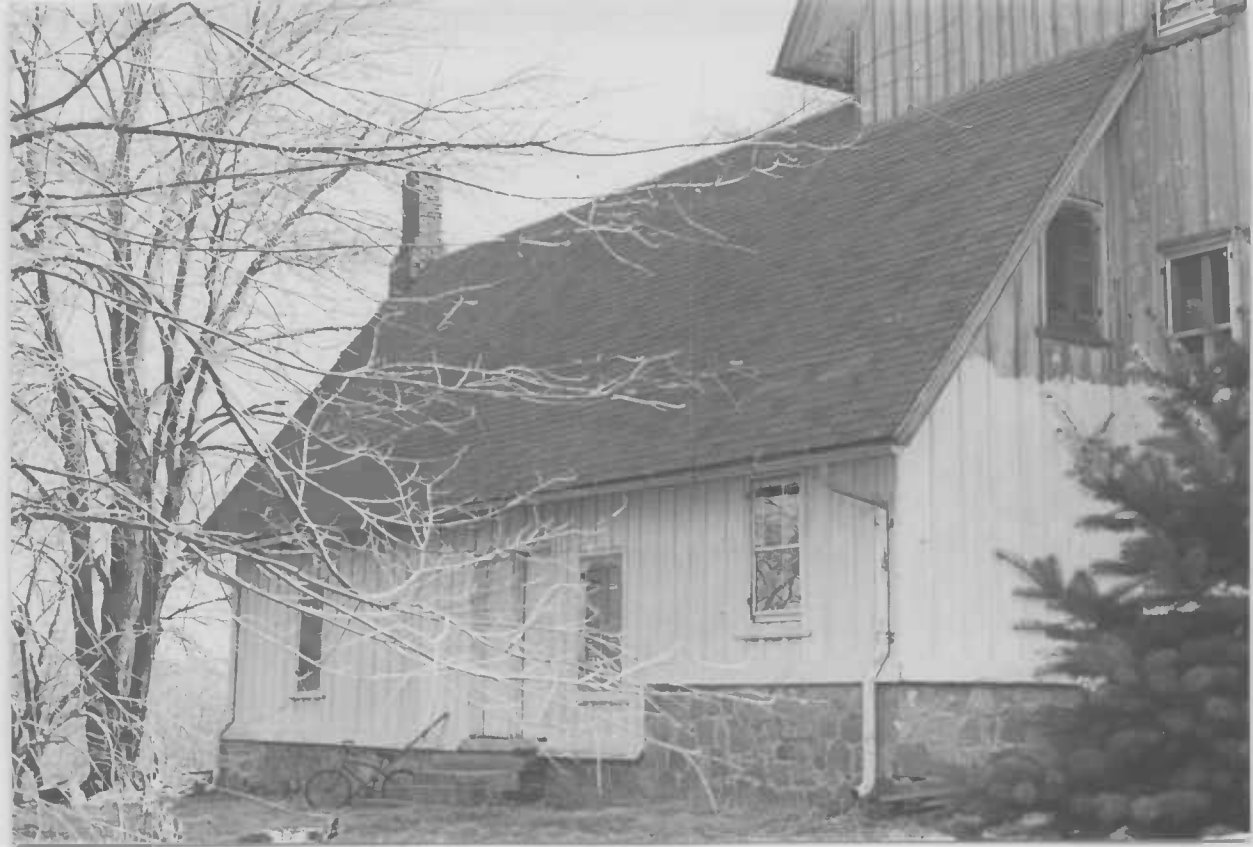
AA-29-N-a (map 22)
"Indian Range"
Service wing
North elevation

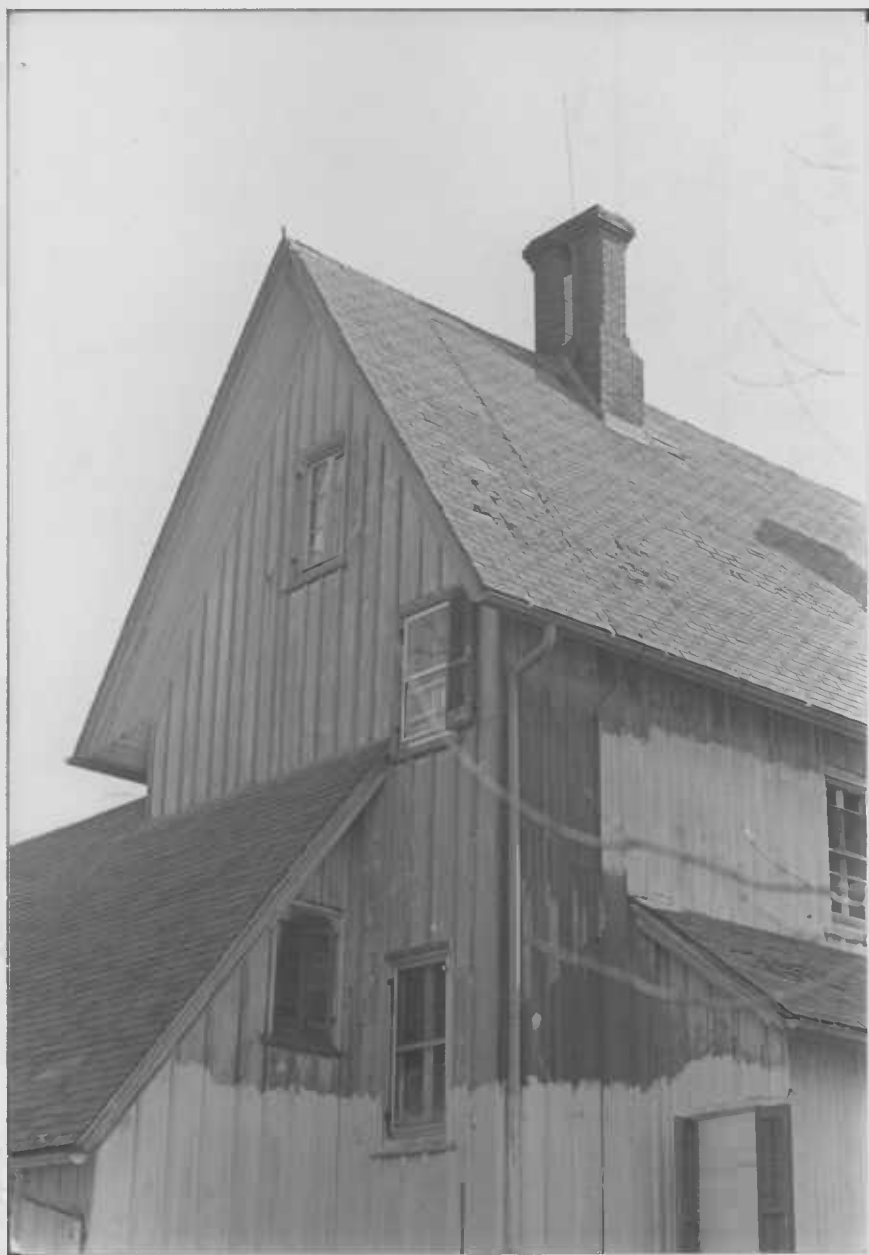
aa-29-N-a^(map 22)
"Indian Range"
detail north wing
